Manhole Inspection Summary

Manhole # S43E__029MH

Insp Date: **4/22/08 2:38 PM**

Location Address: **Moyer St**

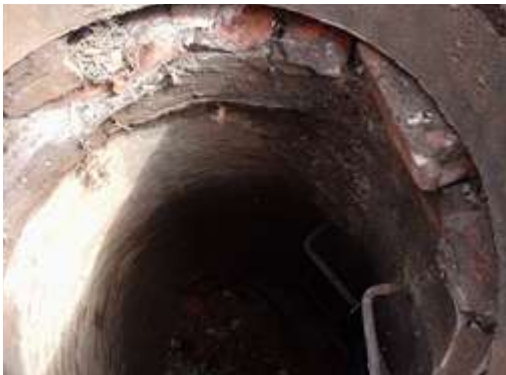
Defect 1

Condition: ☐ Sound ☐ Cracked ☐ Root Intrusion ☒ **Loose Brick** ☒ **Deteriorated**

Deterioration

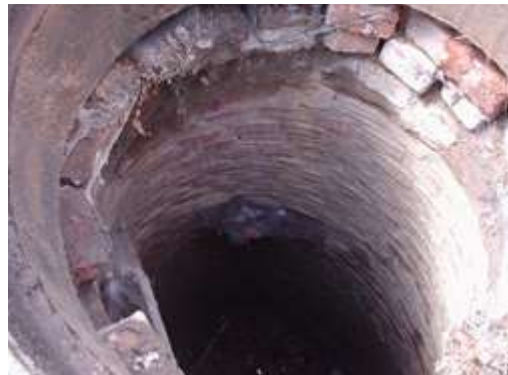
Defect 2

Loose Bricks

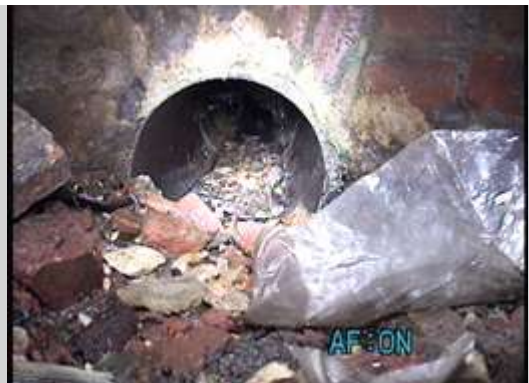
12 O'Clock Outflow

8 in. Circular Gravity Sewer
Pipe Out @ 12 O'Clock

Deposits: ☐ None ☐ Mud ☐ Sludge ☒ **Debris** ☐ Grease

Silt Depth: **4** (in.) Deposits Extent: **Medium**
